Photographic Log for Memphis Regional Intermodal Facility

Operator:		Site Location:	Tracking No.:
Norfolk Southern Railway Company		Rossville, Fayette County	TN0081108
Photo No.	Date		
1	8-30-12		
Description <ul style="list-style-type: none"> • Phase 1A EC-11 • The swale located south of the eastern wye track and main line track up-gradient from SW23 is shown in this photo. • The bottom of the swale appeared to be sufficiently stabilized/vegetated. However, the slopes of the berm were not - see photo 2 for close-up of berm. • Although the berm appears to have more established vegetation than during the March 12, 2012, inspection, the berm remains insufficiently stabilized/vegetated.

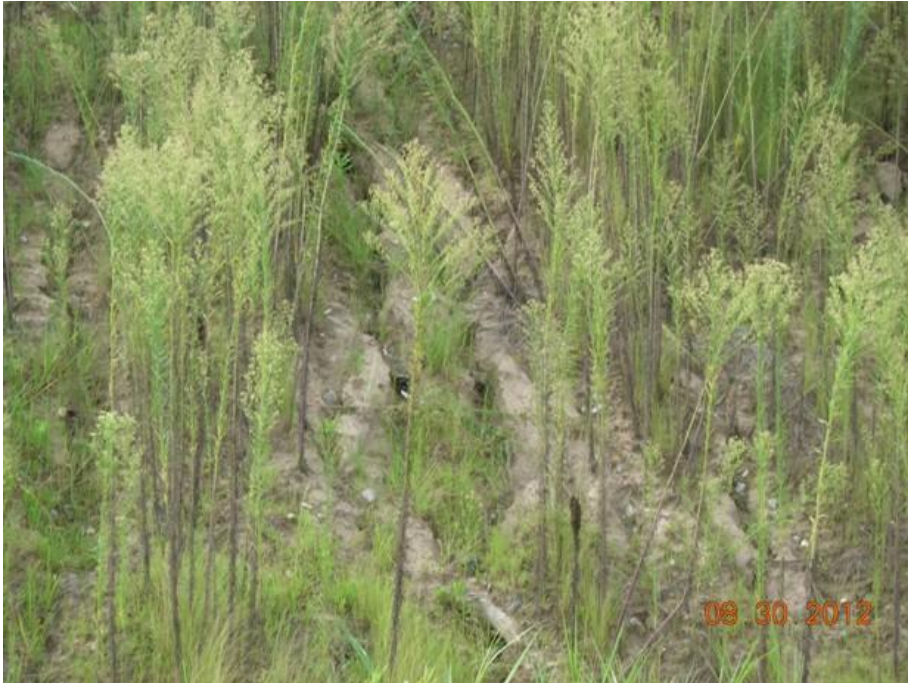
Photo No.	Date		
2	8-30-12		
Description <ul style="list-style-type: none"> • Phase 1A EC-11 • A close-up of the berm located south of the eastern wye track shown in photo 1 is shown in this photo. • Rills and gullies were observed. • The berm was not sufficiently stabilized/vegetated with permanent perennial vegetation. • Although the berm appears to have more established vegetation than during the March 12, 2012, inspection, the berm remains insufficiently stabilized/vegetated.

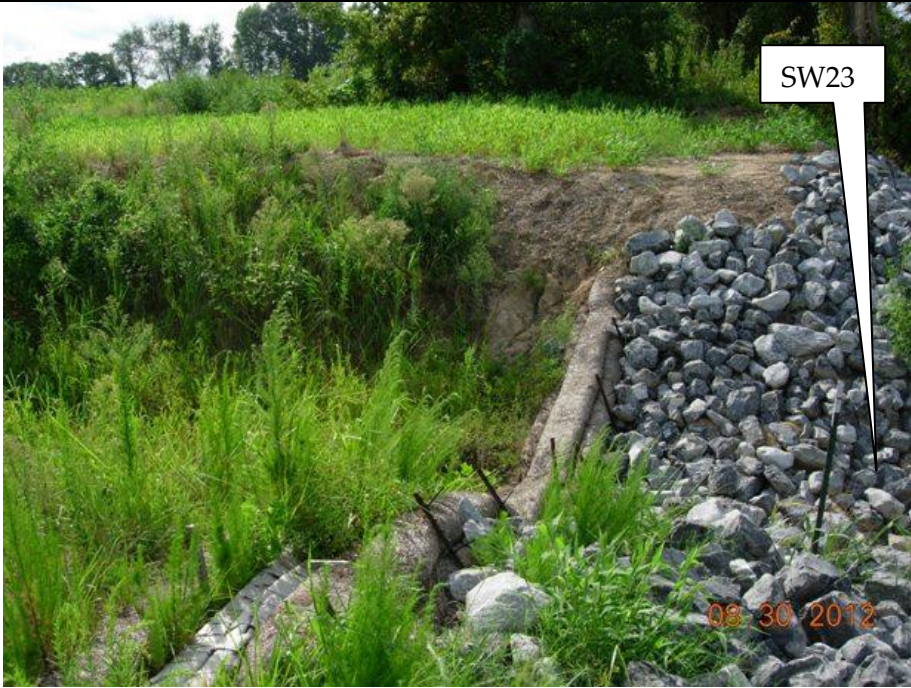
3	8-30-12		
Description <ul style="list-style-type: none"> • Phase 2 EC-21 • SW23 • The lower portion of the swale leading to SW23 appeared to be sufficiently stabilized/vegetated in some areas. However, erosion was observed on the slope adjacent to the rip rap.

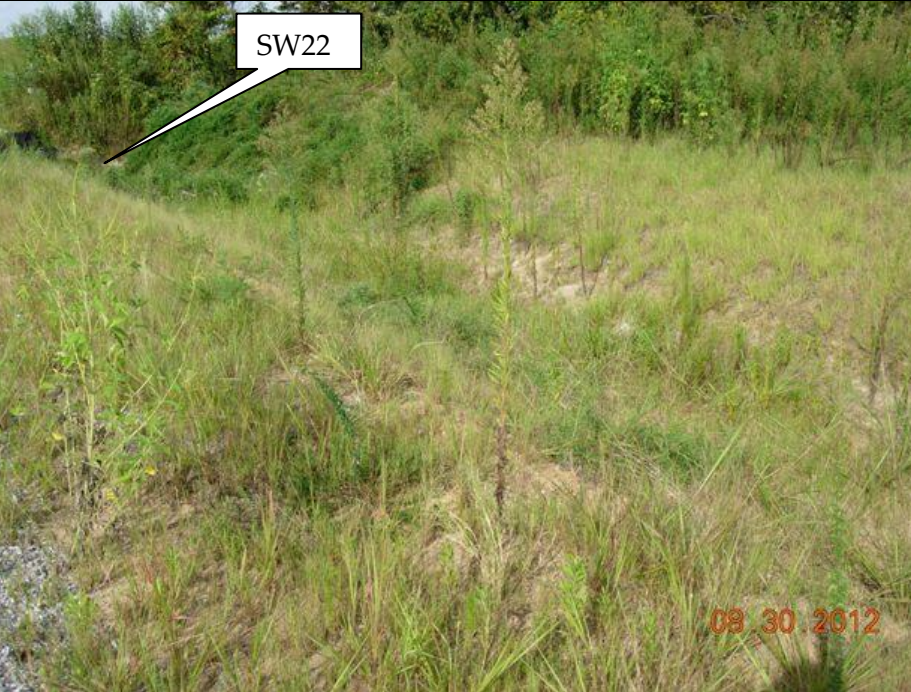
4	8-30-12		
Description <ul style="list-style-type: none"> • Phase 2 EC-21 • SW22 • The swale leading to SW22 appeared to be sufficiently stabilized/vegetated in some areas. However, insufficiently stabilized/vegetated areas were observed throughout the swale/slope.

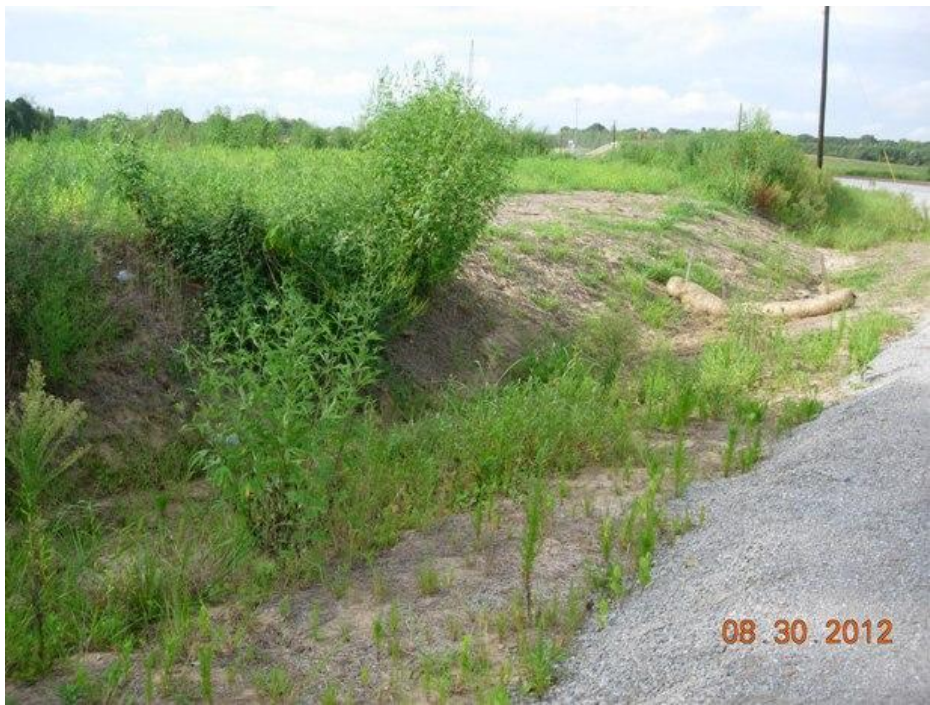
Description <ul style="list-style-type: none">• Phase 2 EC-21• SW24• The swale leading to SW24 appeared to be sufficiently stabilized/vegetated in some areas. However, insufficiently stabilized/vegetated areas were observed throughout the swale/slope.			
Photo No. 6	Date 8-30-12

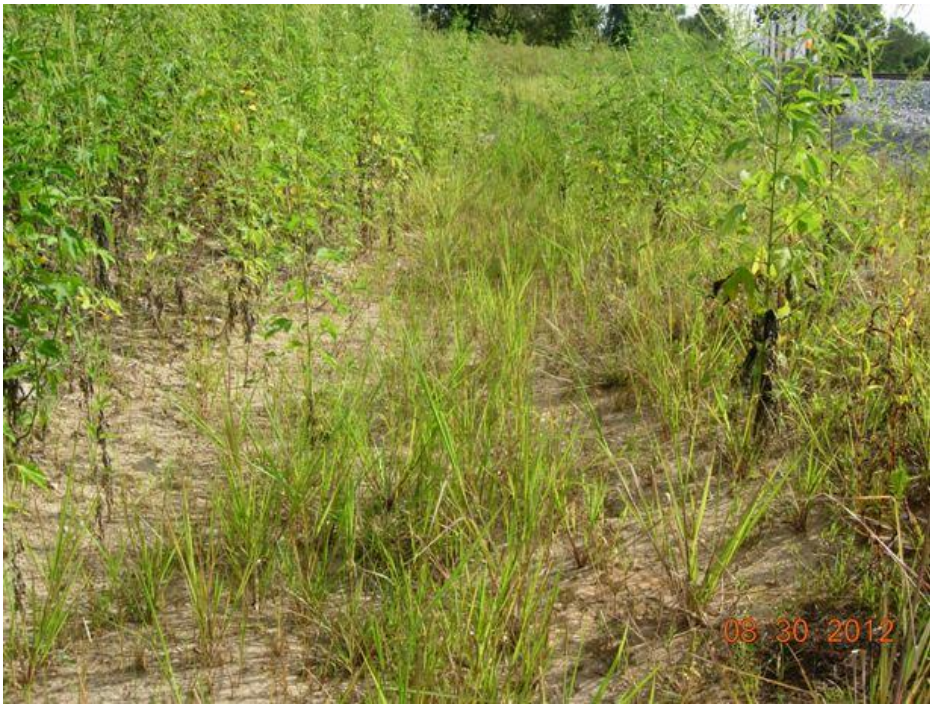
Description <ul style="list-style-type: none">• Phase 2 EC-21• SW25• The swale leading to SW25 appeared to be sufficiently stabilized/vegetated in some areas. However, insufficiently stabilized/vegetated areas were observed throughout the swale/slope.• Erosion gullies were observed adjacent to the rip rap located on the bank of Stream 5.

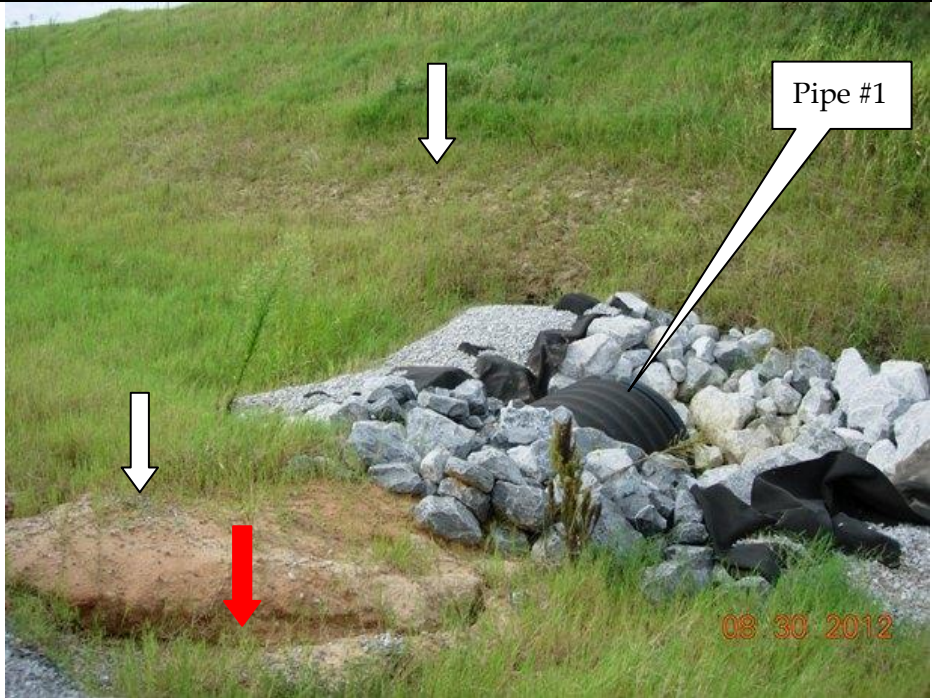
9	8-30-12		
Description <ul style="list-style-type: none"> • Phase 2 EC-21 • Pipe #1 • The swale conveying drainage to Pipe #1 appeared sufficiently stabilized/vegetated in areas. However, sparse vegetation was observed in areas including but not limited to the slope up-gradient (white arrows) and adjacent to the pipe. • A gully has formed adjacent to the top of the pipe (red arrow).

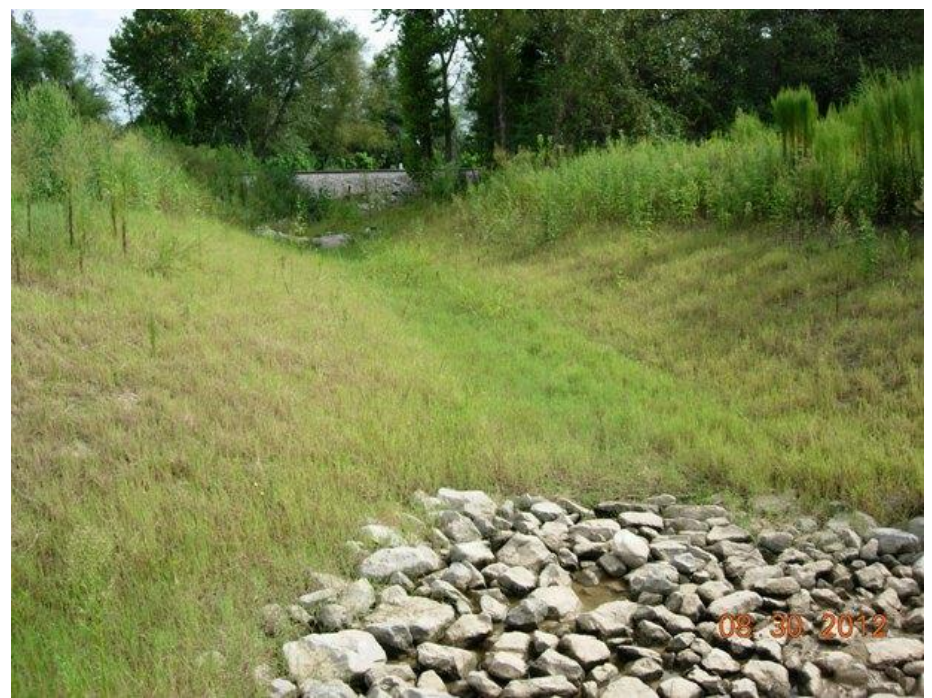
10	8-30-12		
Description <ul style="list-style-type: none"> • Phase 2 EC-21 • SW21 • The vegetative cover on the banks and bottom of the swale down-gradient from Pipe #1 and up-gradient from SW21 appeared sufficiently stabilized/vegetated with the exception of an area at the top of the headwall.

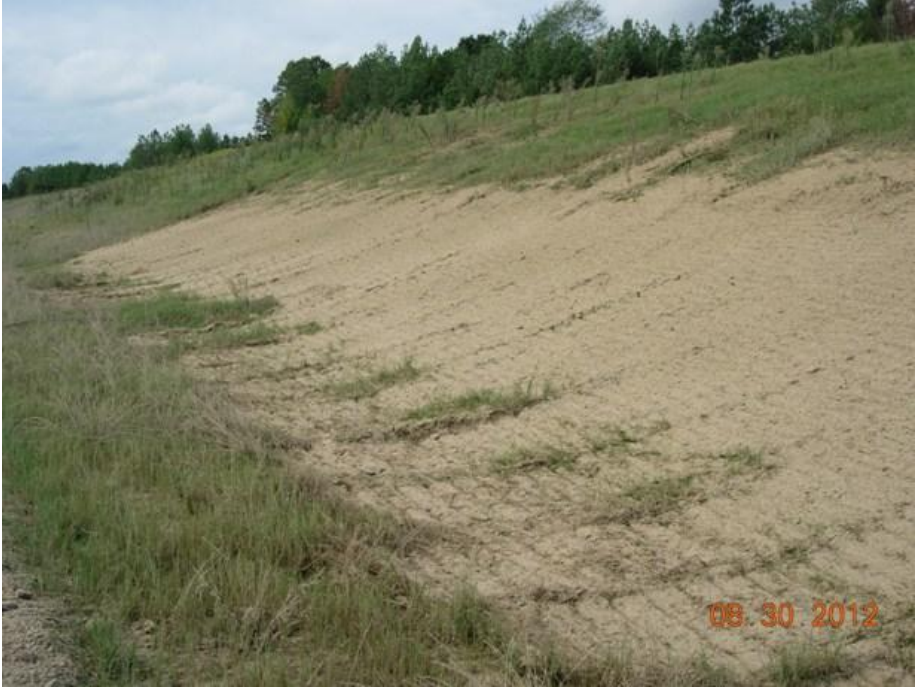
11	8-30-12		
Description <ul style="list-style-type: none"> • Phase 2 EC-23 • The noise berm at approximately Lead Track L-1 Station 35+00 is shown in this photo. • Ms. Hagerty indicated that because slope failure had been observed, the berm had recently been re-graded and sprayed with ProMatrix. • Vegetative growth in the newly sprayed areas was not observed. • Insufficient stabilization/vegetation was previously documented during inspections conducted on August 23, 2011, and March 12, 2012. 			
Photo No.	Date

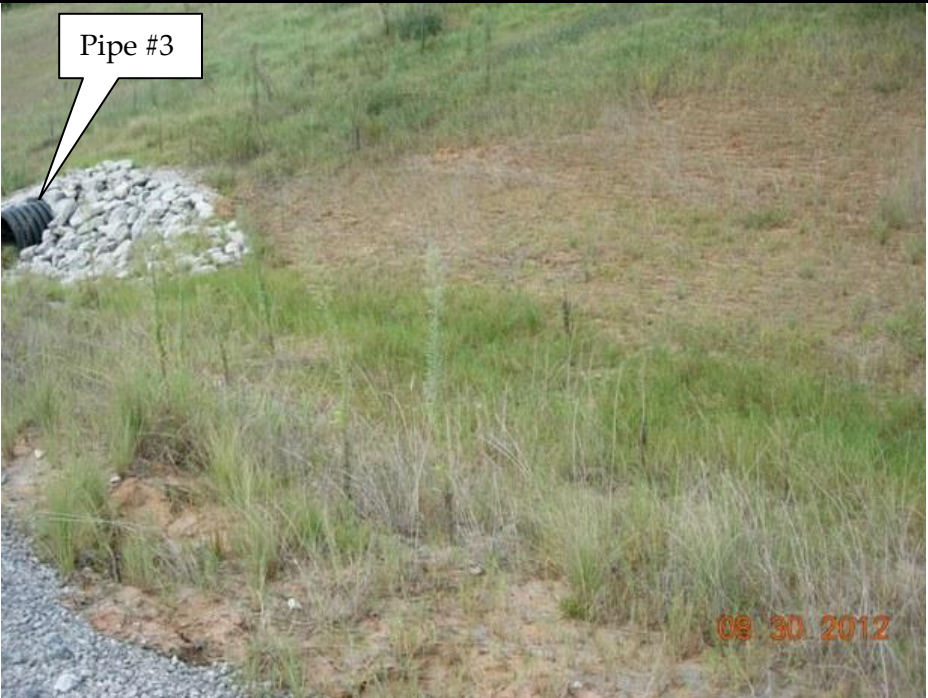
12	8-30-12		
Description <ul style="list-style-type: none"> • Phase 2 EC-23 • Pipe #3 is shown in the left side of the photo. • Pipe #3 and the swale along the eastern side of the noise berm drain into Pipe #2. • Areas of the slope and swale surrounding Pipes #2 and #3 were not sufficiently vegetated, including but not limited to the transition area between the gravel and vegetation.

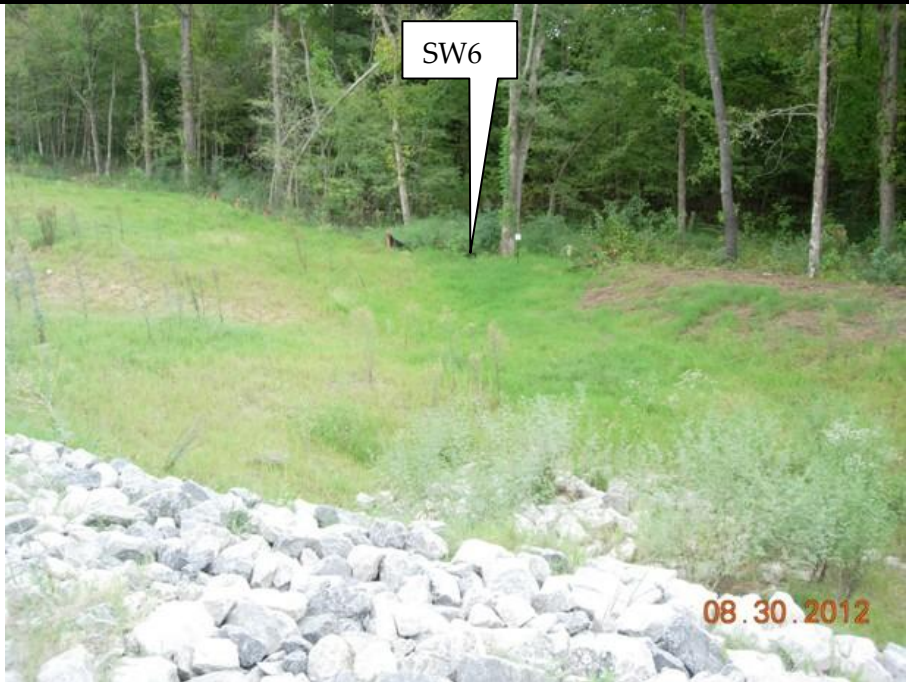
18	8-30-12		
Description <ul style="list-style-type: none"> • Phase 2 EC-24 • SW6 • Most of the area surrounding SW6 appeared sufficiently stabilized/vegetated, except a few areas where sparse vegetative cover was noted.

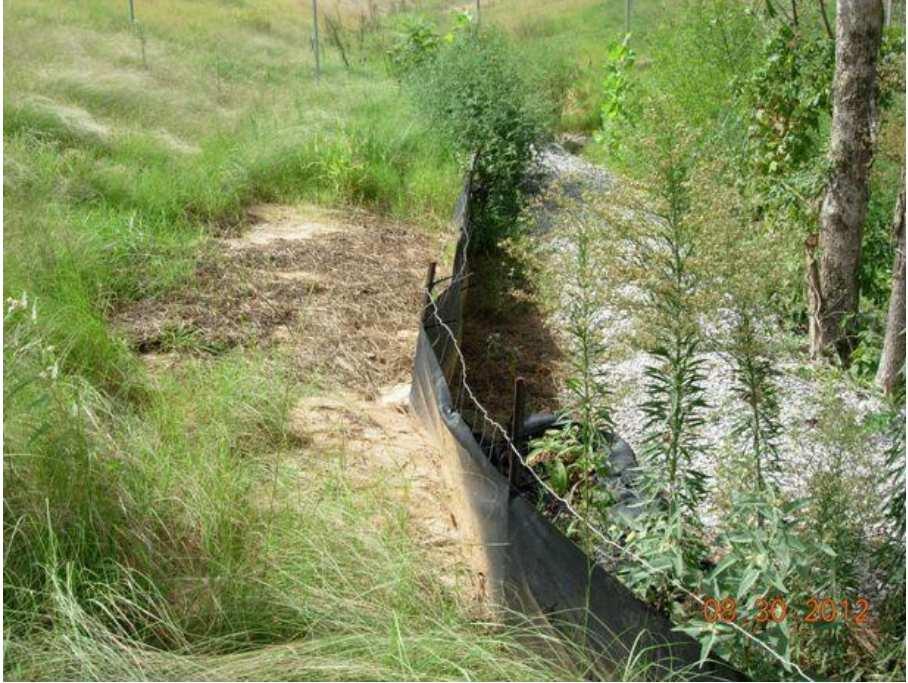
Operator:		Site Location:	Tracking No.:
Norfolk Southern Railway Company		Rossville, Fayette County	TN0081108
Photo No.	Date		
23	8-30-12		
Description <ul style="list-style-type: none"> • Phase 2 EC-24 • The silt fence installed at the toe of the slope adjacent to Stream 3 appeared to be at or near 50% capacity. The sediment accumulation at the toe of the slope was approximately 1 foot higher than the area on the down-gradient side of the silt fence. The same condition was documented during the March 12, 2012, inspection. • Sediment accumulation at the toe of the slope indicates sediment loss from the slope.

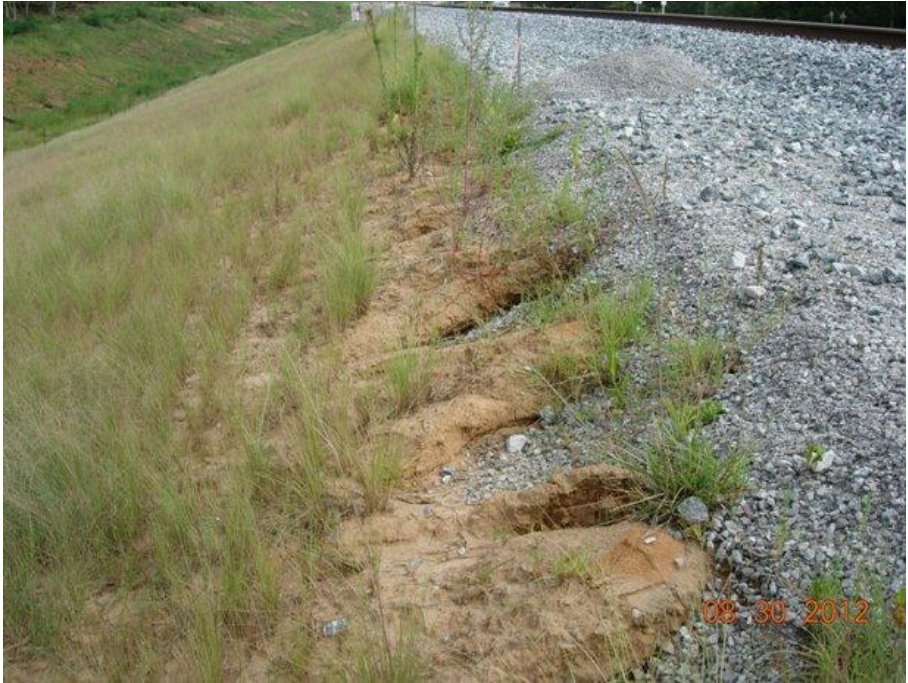
Photo No.	Date		
24	8-30-12		
Description <ul style="list-style-type: none"> • Phase 2 EC-24 • This photo shows an example of the transition area between the gravel/track and the vegetated slope. • The transition area was not sufficiently vegetated. • Rills and gullies were observed. • Ms. Hagerty stated the transition zone will be re-worked.

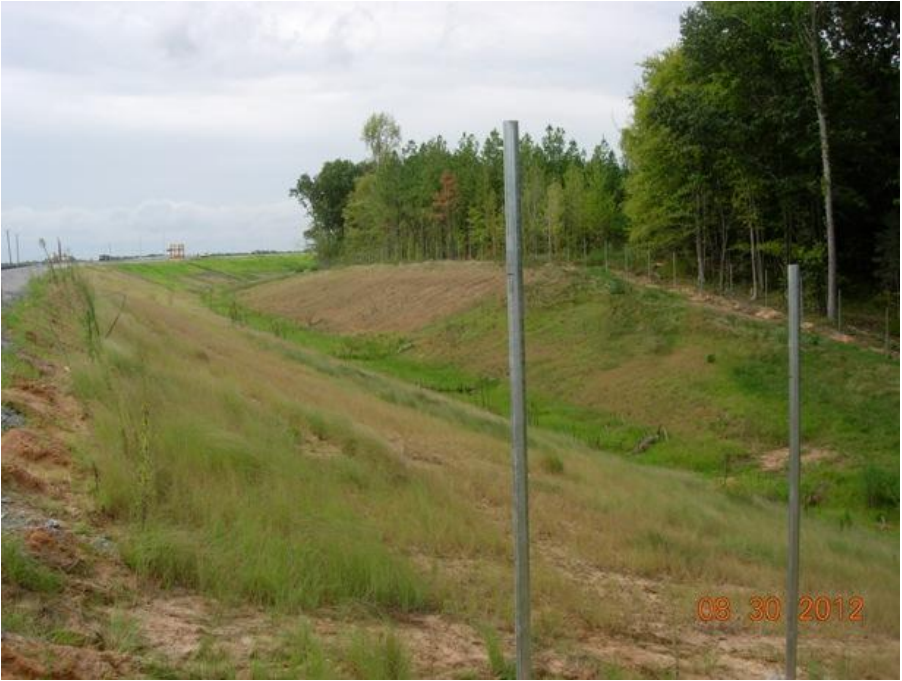
Operator: Norfolk Southern Railway Company		Site Location: Rossville, Fayette County	Tracking No.: TN0081108
Photo No. 25	Date 8-30-12	<div> <div> Description <ul style="list-style-type: none"> • Phase 2 EC-24 • The slope/swale up-gradient from SW28 is shown in this photo. • The portion of the slope/swale shown in the photo appeared mostly sufficiently vegetated; however, areas of insufficient stabilization/vegetation were observed, especially further to the south (see photos 26-27). • The fence installation has also caused disturbance to established vegetation on the slope. • No discharge was occurring from SW28 at the time of the inspection. </div>

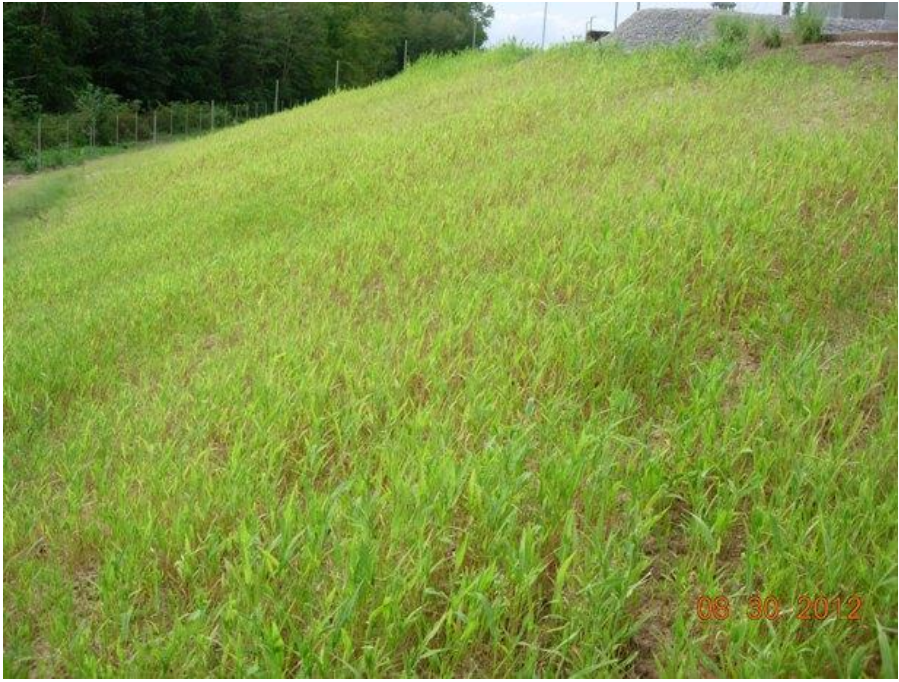
Photo No.	Date	
29	8-30-12	
Description <ul style="list-style-type: none"> • Phase 2 EC-24 • The slope up-gradient of SW7 was recently re-graded and sprayed with Flexterra. • The dominant grass emerging appeared to be rye; however, some Bermuda was observed. • Neither grass was fully established and was therefore unable to provide complete and sufficient cover. • According to the August 23, 2011, inspection documentation, this area was sprayed with Flexterra in August of 2011, yet establishment of sufficient cover has not been accomplished.

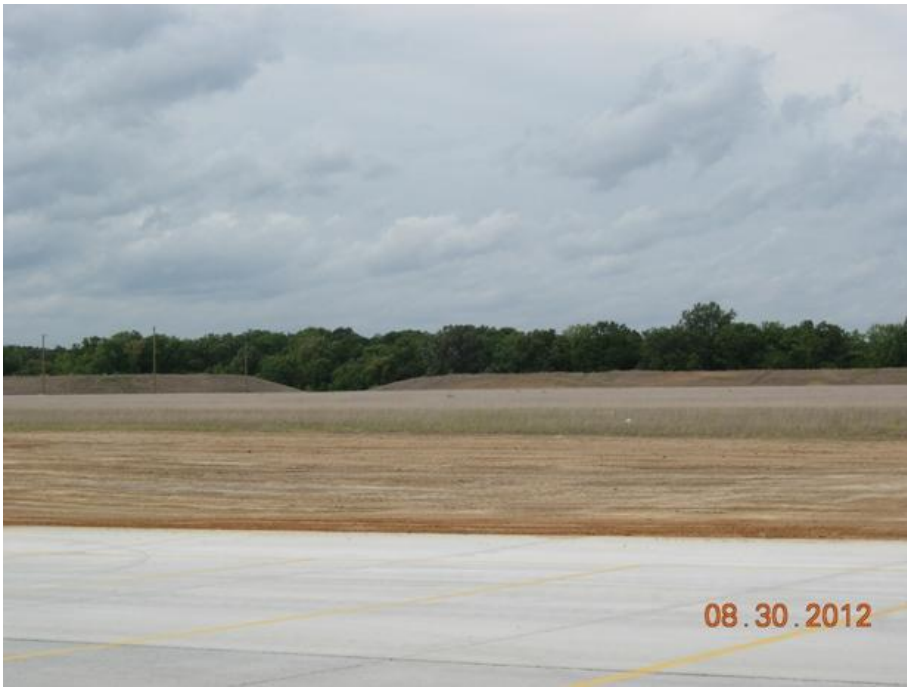
Photo No.	Date	
30	8-30-12	
Description <ul style="list-style-type: none"> • Phase 1A EC-18 and 2 EC-28 • Looking west across the concrete parking/pad area. • An area approximately 60 feet in width west of the concrete was not stabilized. No erosion prevention measures (temporary or permanent) were observed. • The area to the west of the bare area was vegetated, but the vegetation was either dead or dormant and did not appear to be permanent or perennial.

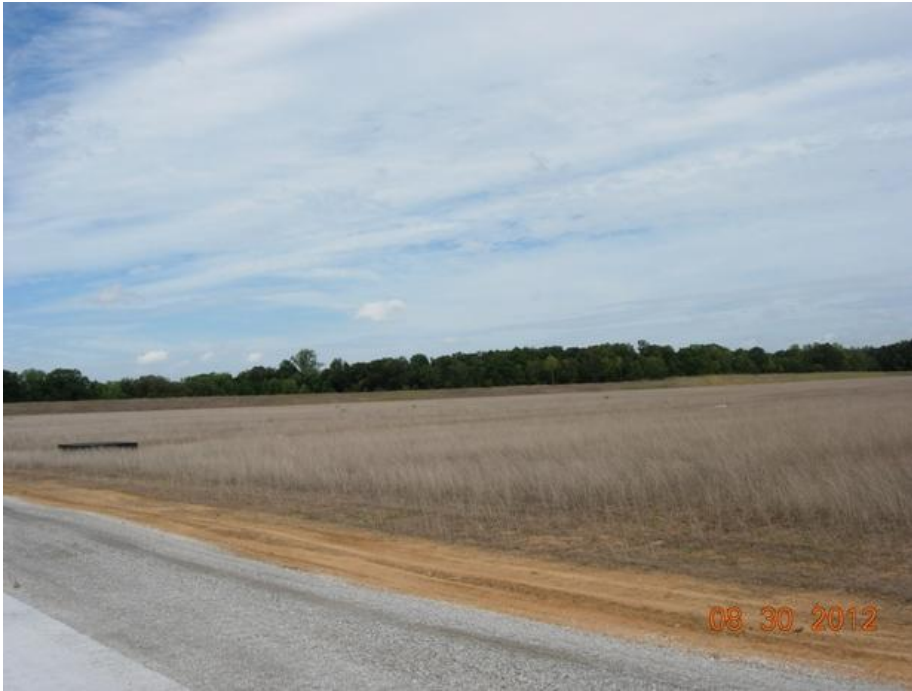
31	8-30-12		
Description <ul style="list-style-type: none"> • Phase 1A EC-18 and 2 EC-28 • Looking northwest across the future expansion area from the yard entrance access road. • The shoulder of the road was covered with gravel. A bare section was observed between the gravel and vegetation. • The vegetation was either dead or dormant and did not appear to be permanent or perennial.

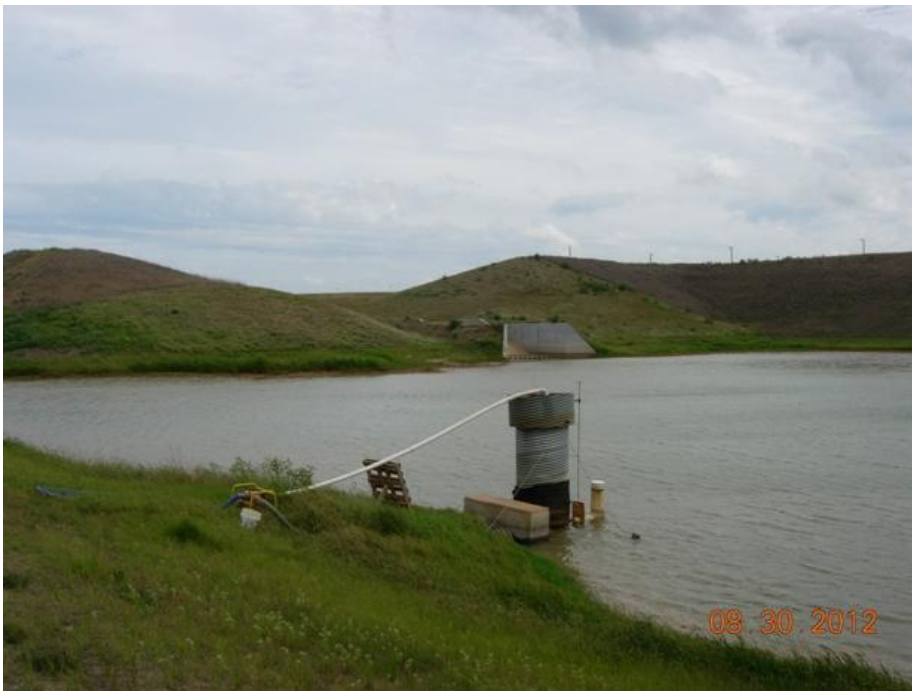
32	8-30-12		
Description <ul style="list-style-type: none"> • Phase 1A EC-19 and 2 EC-29 • Sediment Basin 2 • Looking north at the northern section of the basin. • The vegetative cover on the banks of the basin appeared sufficient in most areas; however, some sparse areas were observed. • The water in the basin had been chemically treated and was being dewatered via a pump to SW30.

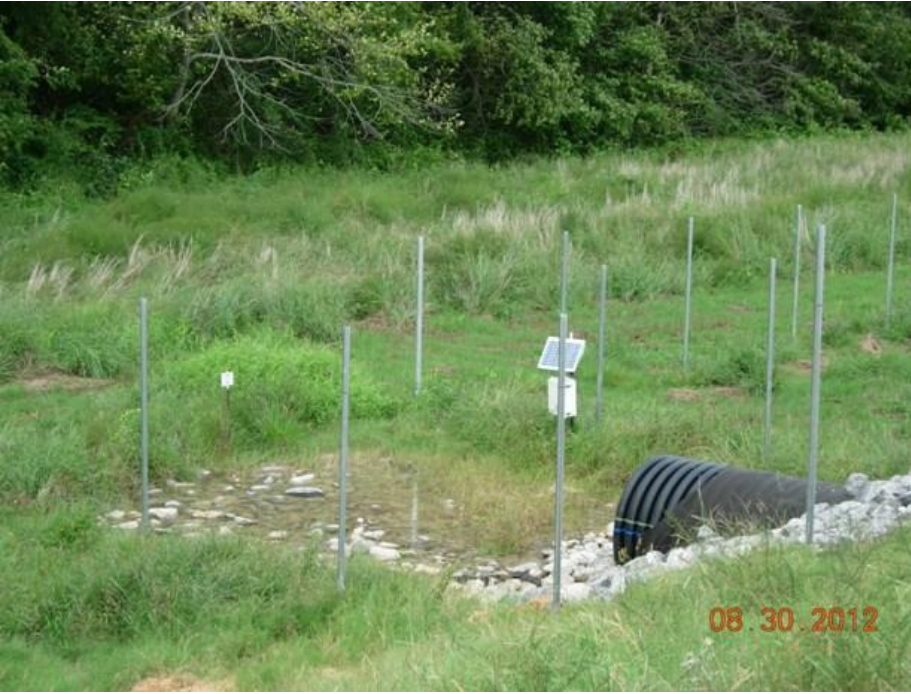
- Phase 2 EC-29
- SW30
- Sediment Basin 2 was being dewatered via SW30.
- The discharge water was clear.
- The slope adjacent to SW30 appeared to be sufficiently vegetated.
- Minor disturbance was observed associated with the fence installation.

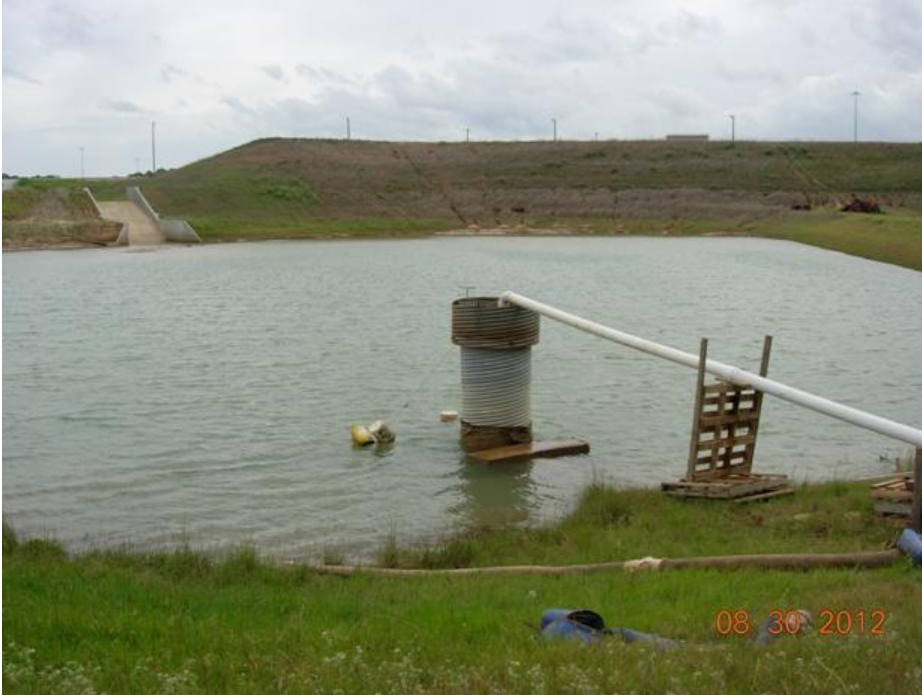
35	8-30-12		
Description <ul style="list-style-type: none"> • Phase 1A EC-19 and 2 EC-29 • Sediment Basin 3 • Looking east across the basin. • The vegetative cover on the banks of the basin appeared sufficient in most areas; however, some sparse areas were observed. • Rills and gullies were observed on the western facing bank (see photos 36-37). • Rills and gullies were also observed during the previous inspection on March 12, 2012. • The water in the basin had been chemically treated and was being dewatered via a pump to SW31. 			
Photo No.	Date

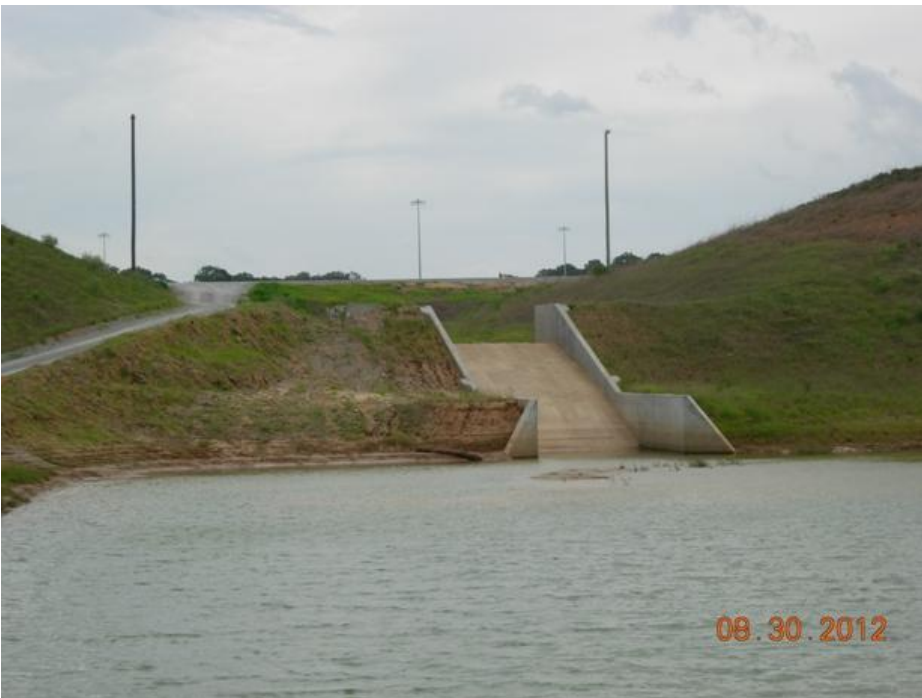
36	8-30-12		
Description <ul style="list-style-type: none"> • Phase 1A EC-19 and 2 EC-29 • Sediment Basin 3 • The area surrounding the concrete flume was not sufficiently stabilized. • Rills and gullies were observed.

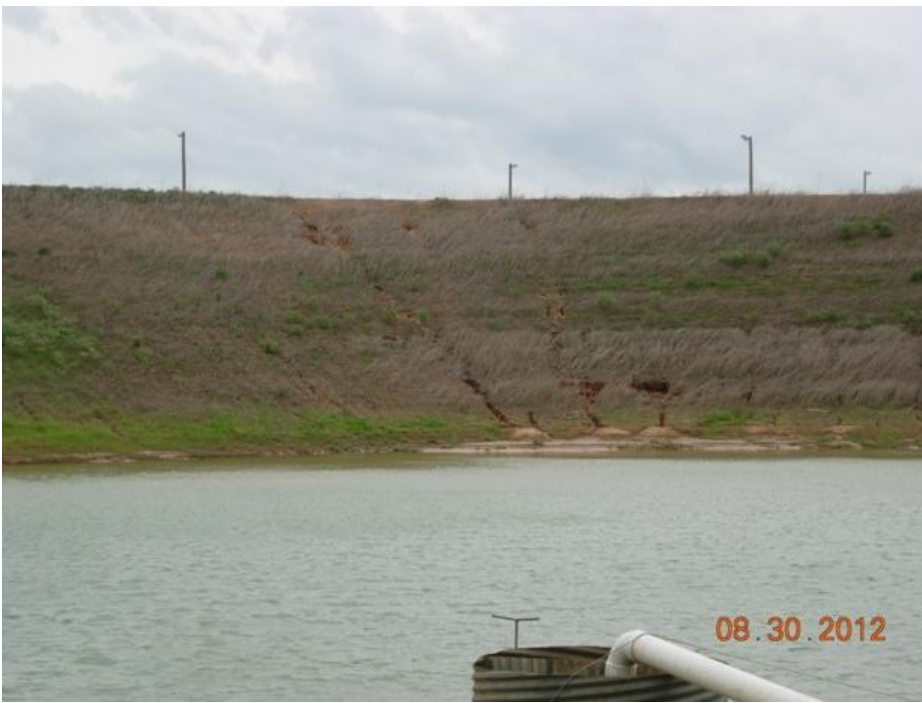
37	8-30-12		
Description <ul style="list-style-type: none"> • Phase 1A-EC-19 and 2 EC-29 • Sediment Basin 3 • The western facing slope was not sufficiently stabilized. • Rills and gullies were observed. • Rills and gullies were also observed during the previous inspection on March 12, 2012.

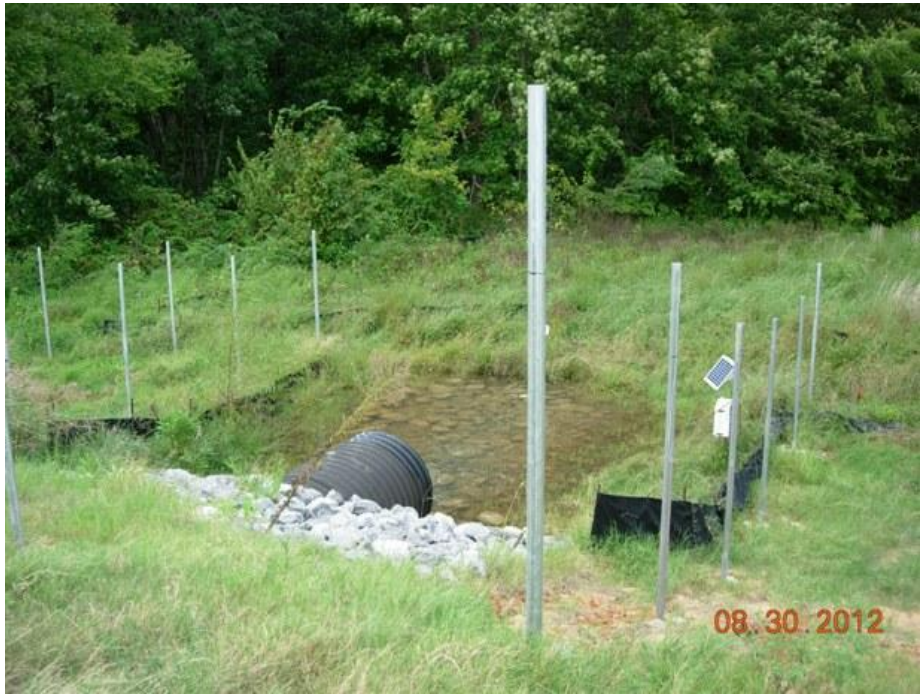
38	8-30-12		
Description <ul style="list-style-type: none"> • Phase 2 EC-29 • SW31 • Sediment Basin 3 was being dewatered via SW31. • The discharge water was clear. • The slope adjacent to SW31 appeared to be sufficiently vegetated, except an area to the north of the outfall (see photo 39) and disturbance being caused by the installation of the fence.

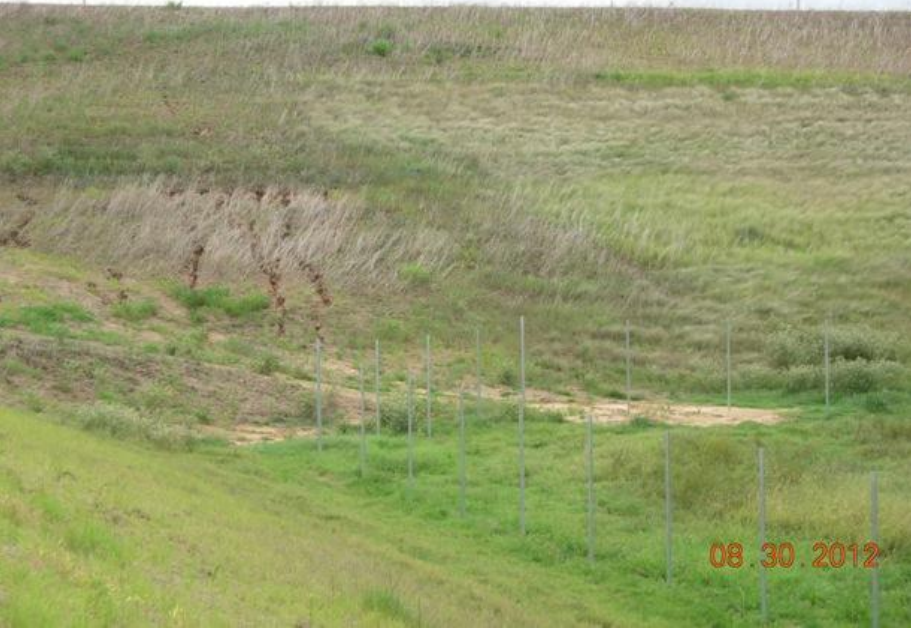
40	8-30-12		
Description <ul style="list-style-type: none"> Phase 1A EC-19 and 2 EC-29 This area of the site is south of Sediment Basin 3. Although the slope appeared to have more established vegetation than during the March 12, 2012, inspection, areas of the slope remained sparsely vegetated. Rills and gullies were observed. Sediment accumulation was observed at the toe of the slope indicating sediment loss from the slope.

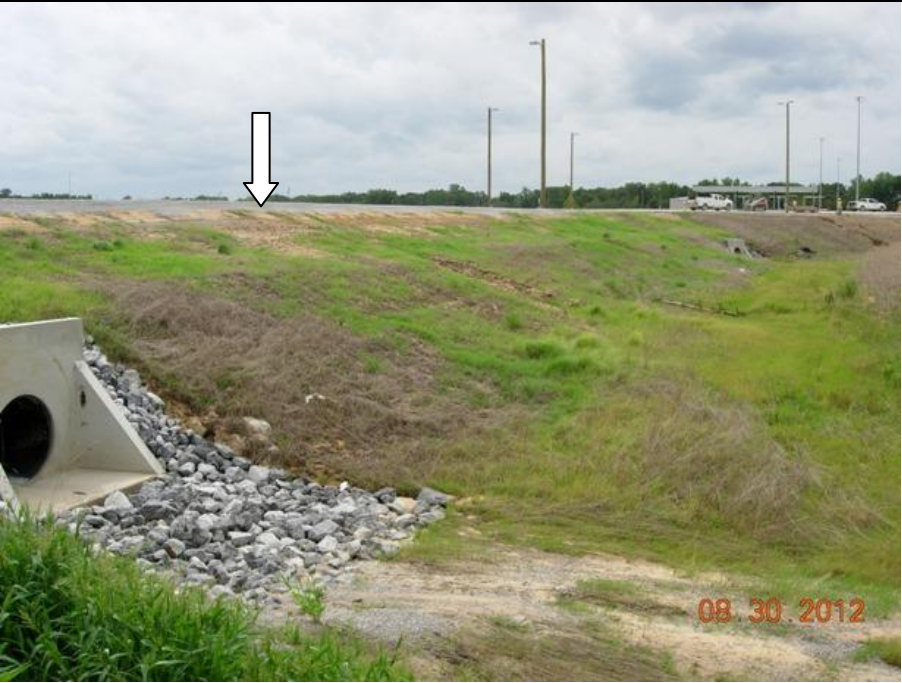
41	8-30-12		
Description <ul style="list-style-type: none"> • Phase 1A EC-19 and 2 EC-29 • The western portion of the site, east of Sediment Basin 3, discharges into the swale shown in this photo before entering the basin. • A majority of the swale/slope appeared to be sufficiently vegetated. However, areas of sparse vegetation were observed. • The transition zone between the rip rap and slope showed signs of erosion. • The transition zone between the gravel road shoulder and the slope was not sufficiently vegetated (arrow).

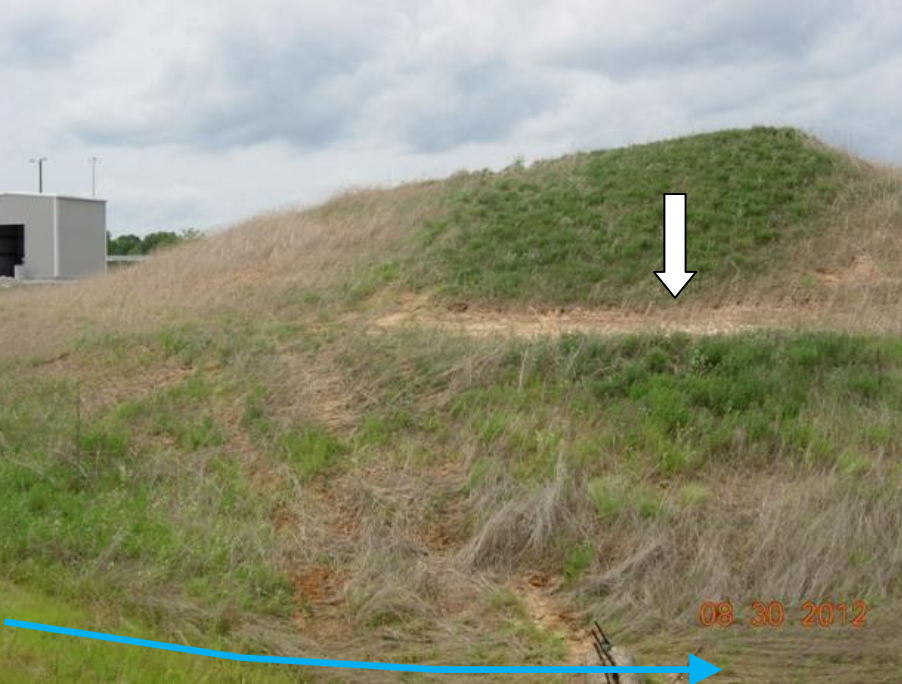
42	8-30-12	
Description <ul style="list-style-type: none"> • Phase 1A EC-19 and 2 EC-29 • Drainage from the area shown in photo 41 flows westward (blue arrow) to the area shown in this photo before entering Sediment Basin 3. • The berm appeared mostly sufficiently vegetated; however, areas of erosion were observed near the middle of the berm (arrow) and some of the vegetation appeared dead or dormant and did not appear permanent or perennial.

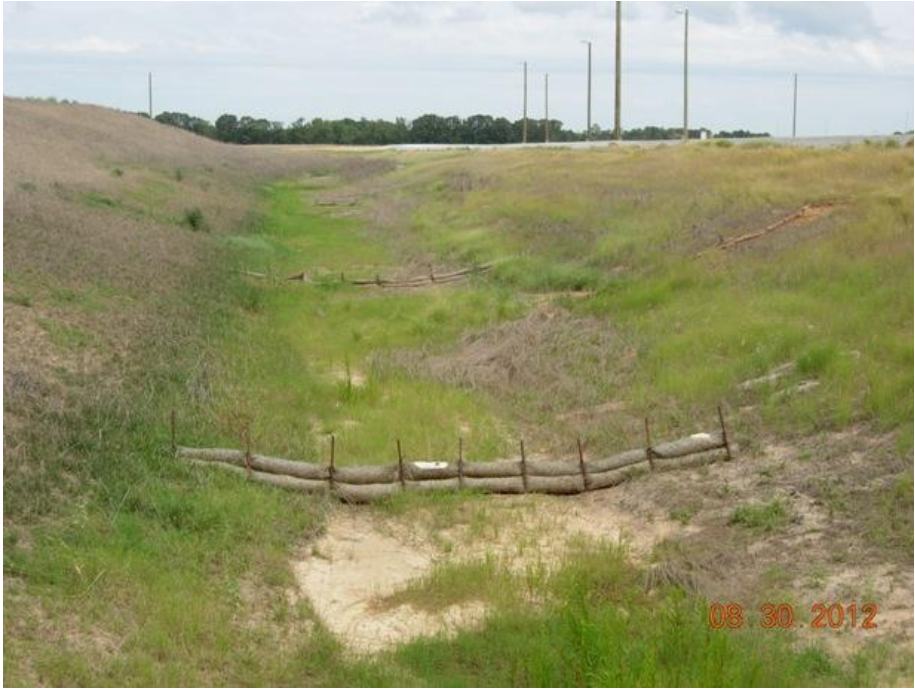
Operator:		Site Location:	Tracking No.:
Norfolk Southern Railway Company		Rossville, Fayette County	TN0081108
Photo No.	Date		
43	8-30-12		
Description <ul style="list-style-type: none"> • Phase 1A EC-19 and 2 EC-29 • The swale on the east side of the eastern berm adjacent to Sediment Basin 2 is shown in this photo. • Drainage from this area discharges into the swale shown in photo 42. • Both slopes appeared vegetated; however, areas of sparse vegetation were observed. • The vegetation in some areas appeared dead or dormant and did not appear permanent or perennial.

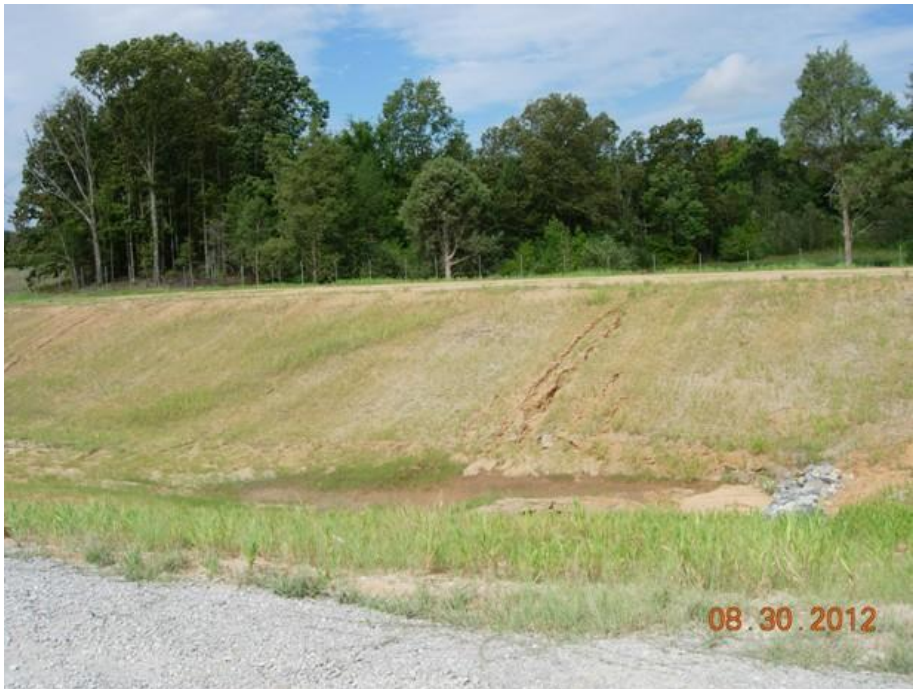
Photo No.	Date		
44	8-30-12		
Description <ul style="list-style-type: none"> • Phase 2 EC-25 • The area surrounding the inlet end of Pipe #13 is shown in this photo. • Pipe #13 discharges into the area shown in photo 45. • The slopes were not sufficiently vegetated. • Rills were observed.

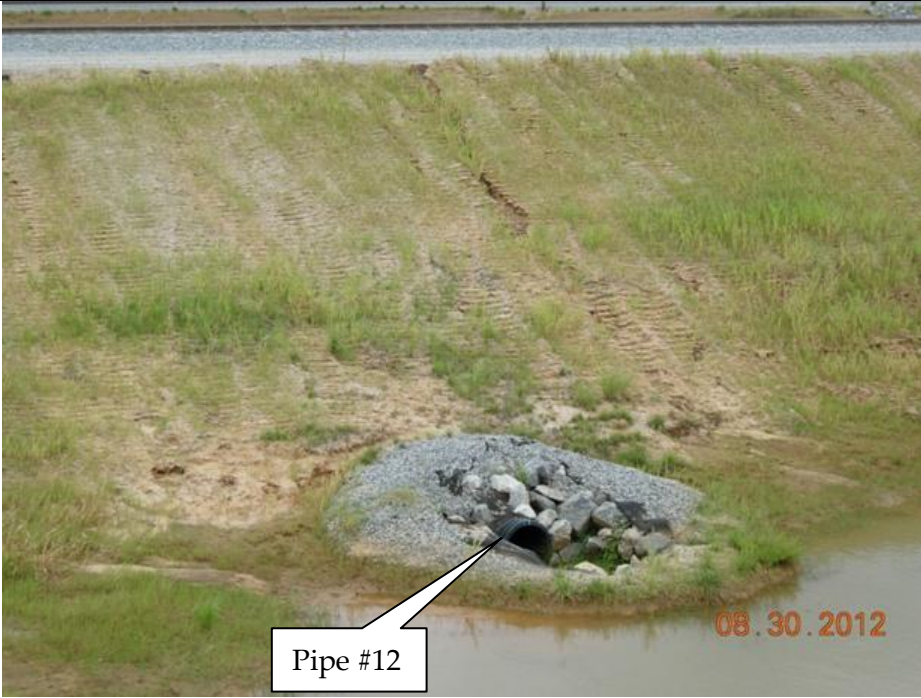
46	8-30-12		
Description <ul style="list-style-type: none"> • Phase 2 EC-25 • The inlet end of Pipe #12 is shown in this photo. • Pipe #12 discharges into Sediment Basin 1. • The area surrounding Pipe #12 was not sufficiently vegetated. • Rills were observed. 		<div style="position: relative; height: 100px;"> Pipe #12 </div>

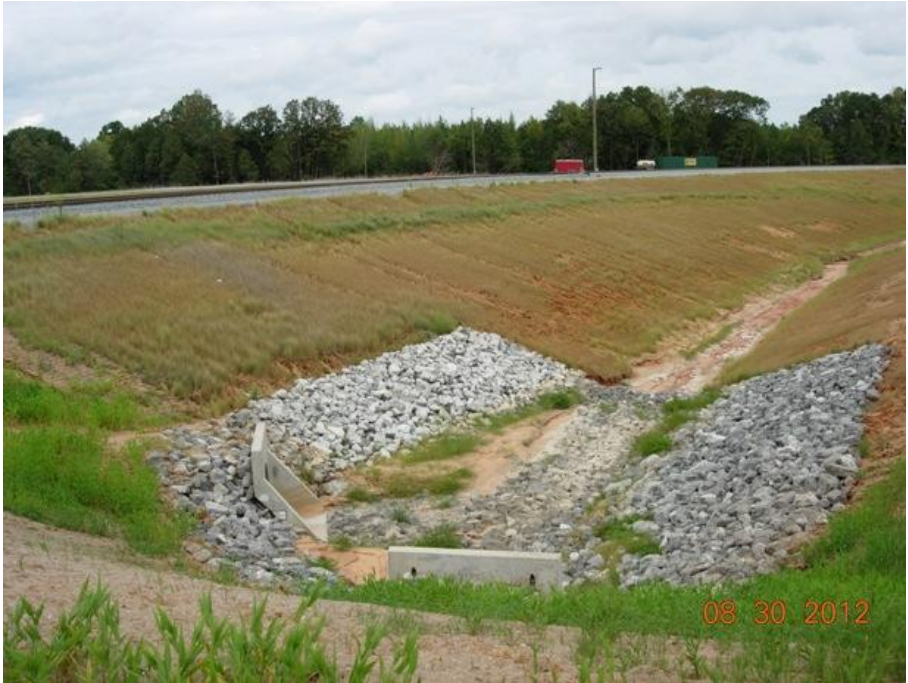
47	8-30-12		
Description <ul style="list-style-type: none"> • Phase 2 EC-25 • Looking north at the southern portion of Sediment Basin 1. • The banks of the basin were not sufficiently stabilized. • Ms. Hagerty indicated that the slope up-gradient from the two headwalls had been recently covered with Flexterra; however, vegetation had not yet established. • Rills and gullies were observed.

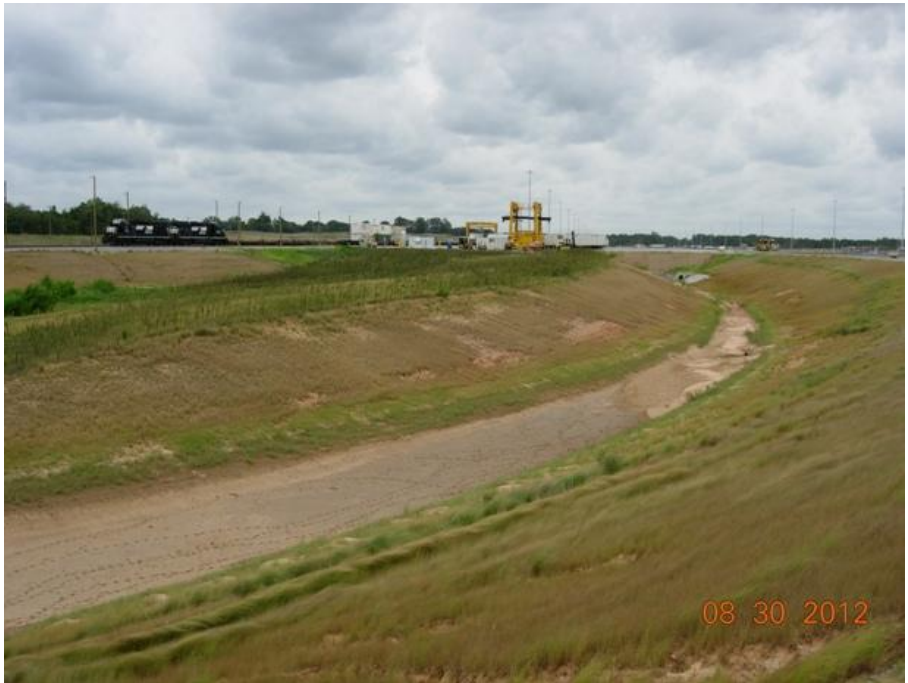
48	8-30-12		
Description <ul style="list-style-type: none"> • Phase 2 EC-25 • Looking south at the southern portion of Sediment Basin 1. • The banks of the basin were not sufficiently stabilized. • Rills and gullies were observed.
